TEST REPORT

Report No.: G2090.01-301-47

TOBIN STEEL COMPANY, INC.
Santa Ana, California

PRODUCT TYPE: Fall Protection Security Bar
SERIES/MODEL: Curb Mount Sky Light Guard

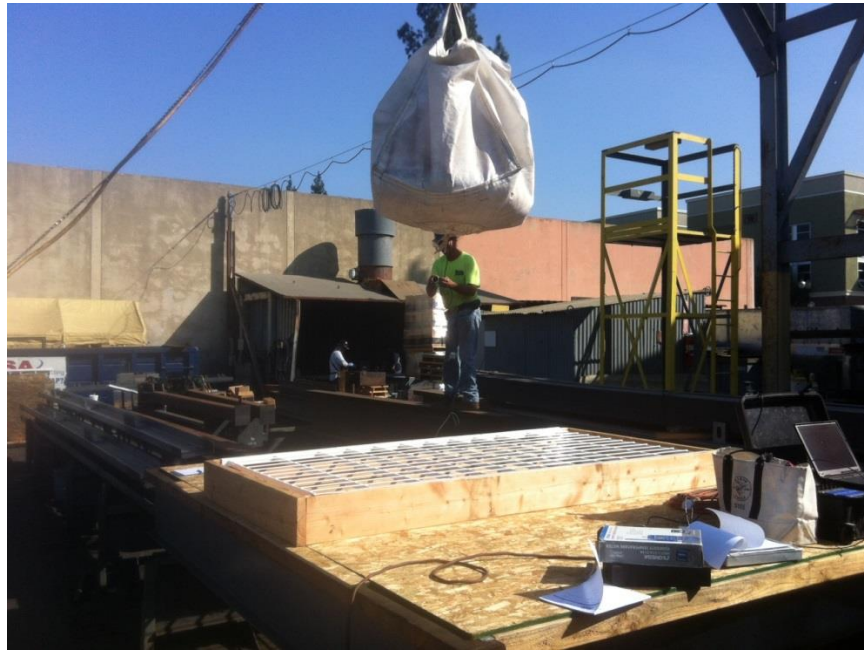
Photo No. 1
Test Specimen #1 prior to drop test

Test Method	Load Location	Results
200 lbf at rest	Center of bars	No visible damage
800 lbf-ft (4' drop height)	Center of bars	Bending of bars, no break in welds or release from curb mounting

Note: Reference Photo Nos. 1-4.

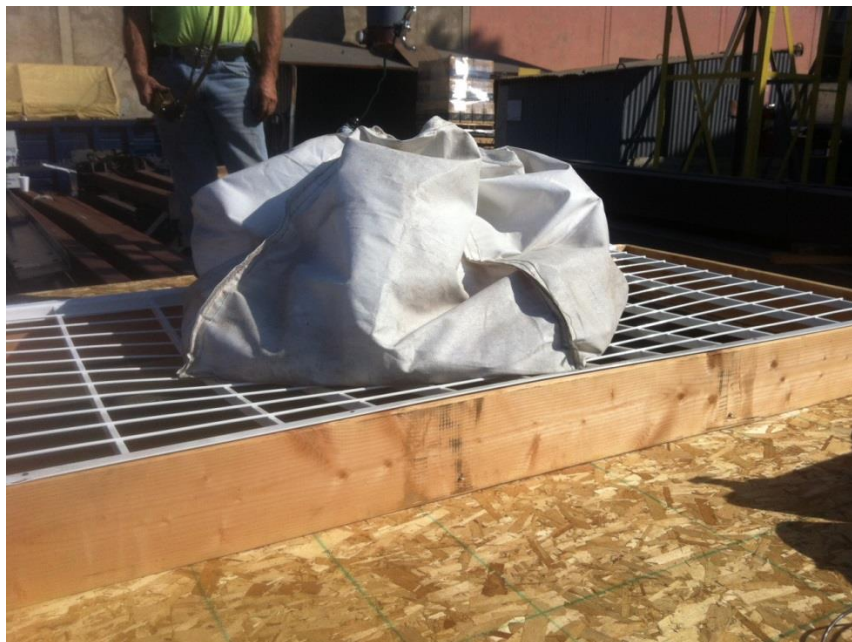
Photo No. 2
Test Specimen #1 after drop test

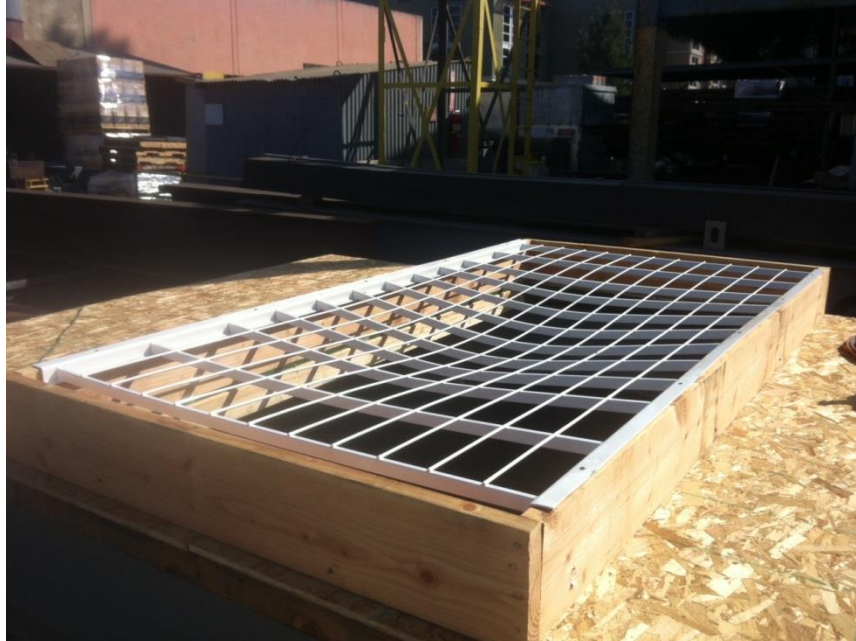
Photo No. 3
Test Specimen #1 deformation after drop test

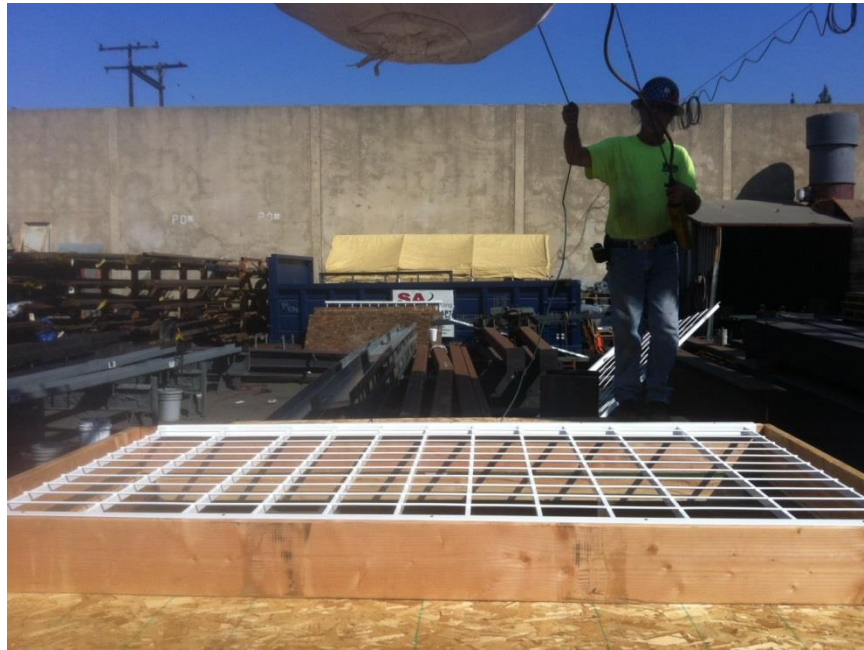
Photo No. 5
Test Specimen #2 prior to drop test

Test Method	Load Location	Results
200 lbf at rest	Center of bars	No visible damage
800 lbf-ft (4' drop height)	Center of bars	Bending of bars, no break in welds or release from curb mounting

Note: Reference Photo Nos. 5-7.

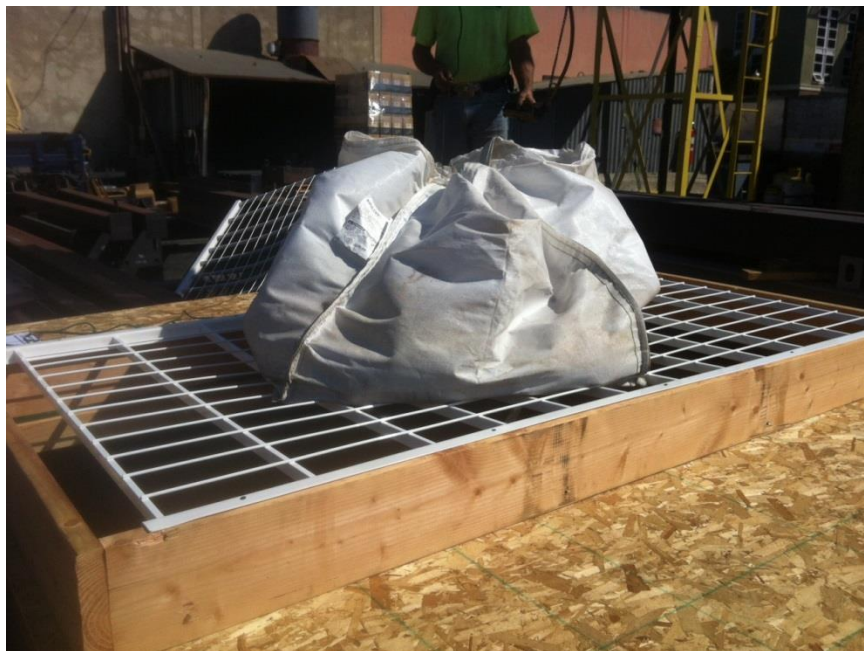
Photo No. 6
Test Specimen #2 after drop test

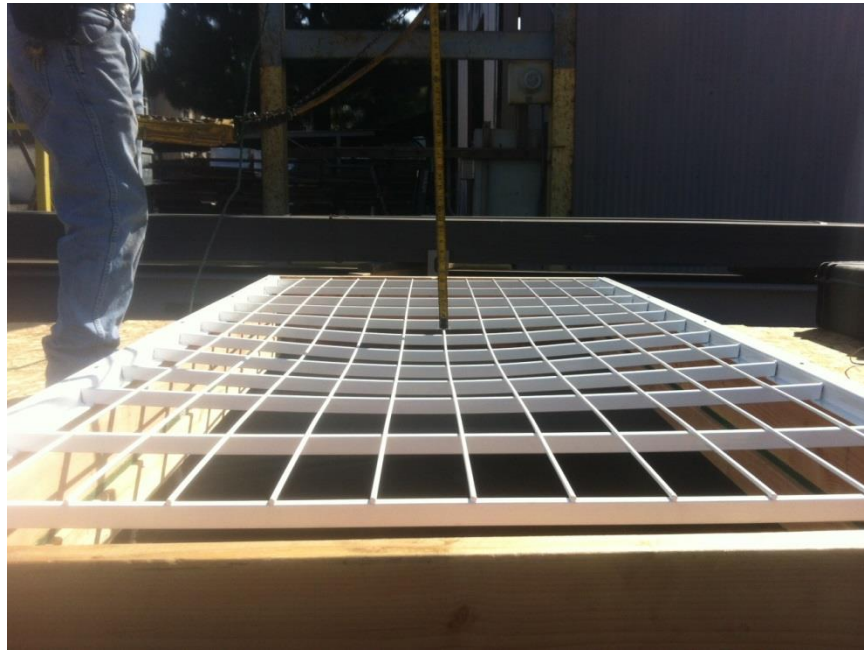
Photo No. 7
Test Specimen #2 deformation after drop test

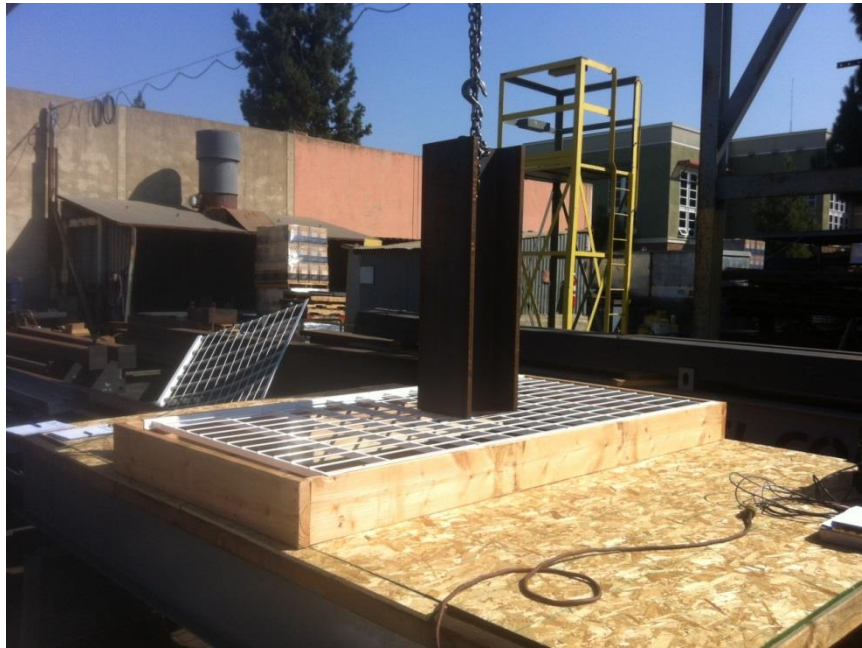
Photo No. 9
Test Specimen #2 during load test

Test	Load Location	Results
400 lbf	Center of bars	No visible damage

Note: The 400 lbf weight was gently applied perpendicular to the center of bar assembly. After 60 seconds of rest time, there was no visible damage to the bar assembly. Reference Photo Nos. 8-11.

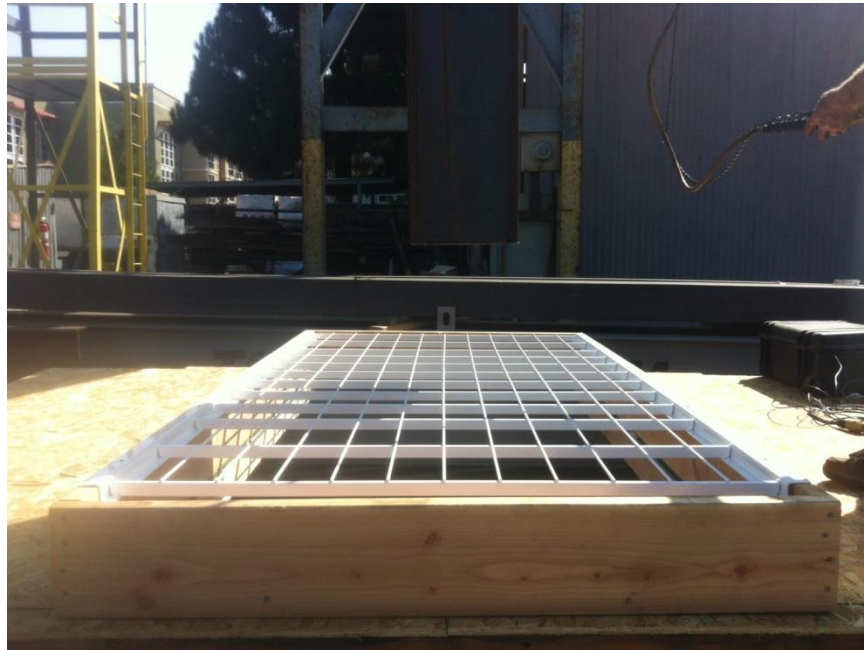
Photo No. 11
Test Specimen #2 after load test
